DUTCH
SAFETY BOARD

Fatal loss of control accident with a Pipistrel Alpha Electro near Stadskanaal airfield

The Hague, July 2020

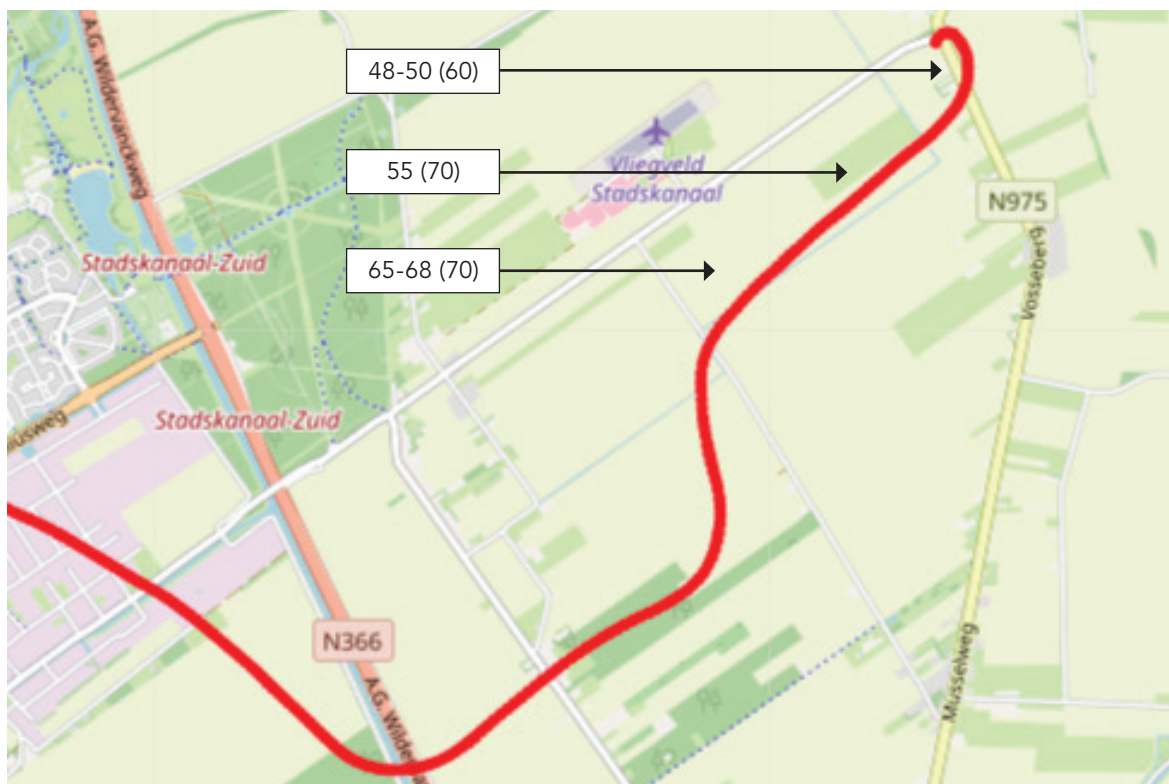
Flight data shows that at the beginning of downwind, the aeroplane was flying airspeeds between 65 and 68 knots IAS. At the end of downwind, the airspeed had reduced to 55 knots IAS. After turning from downwind to base leg, an airspeed of 48 to 50 knots IAS was recorded and a varying left bank angle. When these actually flown airspeeds are compared with the prescribed³³ airspeeds of 70 knots IAS (downwind) and 60 knots IAS (base leg), it can be determined that the actually flown airspeeds were below the recommended airspeeds. The lowest measured airspeed from the flight data is 48 knots IAS; this is just 10 knots higher than the aeroplane's stall speed for level flight with flaps fully extended. These low airspeeds together with the left bank angle caused the aeroplane to manoeuvre in the flight envelop close to the stall. As a consequence, the aeroplane was susceptible to enter an incipient spin.³⁴

Figure 11: The last part of the flight; actual and prescribed (between brackets) airspeeds in knots. (Source: ATC the Netherlands and OpenStreepMap)
