DUTCH
SAFETY BOARD

Crashed after banner pick-up, Piper PA-25-235 Pawnee

The Hague, May 2021

Identification number:	2018045
Classification:	Accident
Date, time of occurrence:	31 May 2018, 10.58 hours ²
Location of occurrence:	Breda International Airport, the Netherlands (EHSE), formerly known as Seppe Airfield
Registration:	SE-KHF
Aircraft type:	Piper PA-25-235 Pawnee D
Aircraft category:	Single engine piston (SEP)
Type of flight:	Commercial banner towing
Phase of operation:	Climb out after picking up of banner
Damage to aircraft:	Destroyed
Flight crew:	One
Passengers:	None
Injuries:	Pilot, fatally injured
Other damage:	None
Light conditions:	Daylight

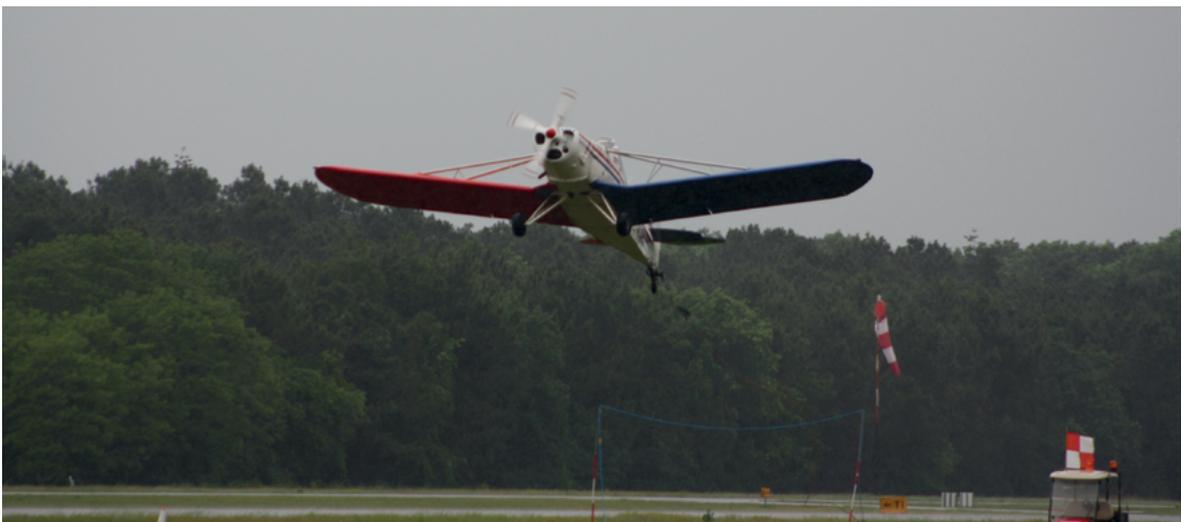
Figure 1: Banner pick-up accident flight. (Source: De Haan)

At 10.58 hours the aeroplane picked up the banner (see Figure 1). During the pick-up, the banner deployed normally. After the pitch up manoeuvre and levelling off, the aeroplane almost immediately began to lose altitude with a wings level and a nose high attitude. This is illustrated by the compilation of video stills in Figure 2. The aeroplane had its flaps in the up position during the pick-up manoeuvre. This is the normal flap setting for the pick-up manoeuvre and climb out. The aeroplane continued to fly in a descending flight path veering slightly to the left, passing over a residence bordering the airport at approximately 100 feet (see Figure 3).

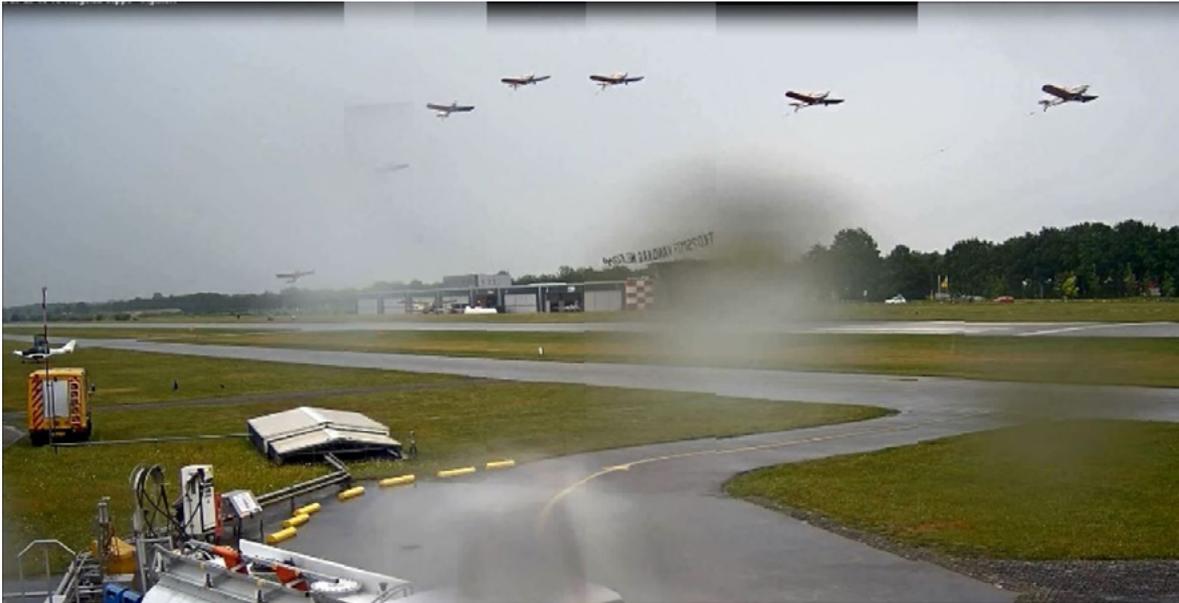
Figure 2: Video compilation of the moment of the banner pick-up and the descending flight path. (Source: Breda International Airport, modified by the Dutch Safety Board)

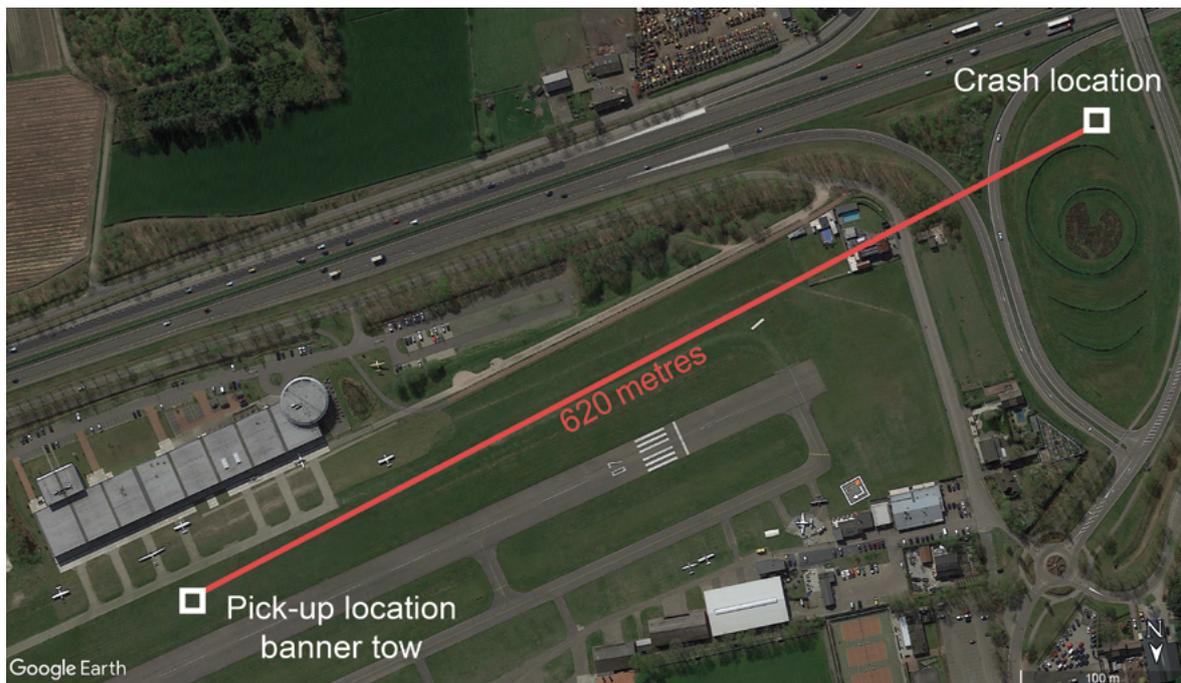
Figure 3: The grass strip, banner pick-up point and the crash location at Breda International Airport. (Source: Google Earth)

The aeroplane crashed on a grass area of a curved ramp leading towards the highway south of the airfield (see Figure 3). The impact with the ground was in a near vertical nose down attitude which caused the wooden propeller blades to completely disintegrate. Many parts of the propeller were found at a distance from the impact point on the grass area. The aeroplane structure was buckled at the cockpit area and distorted by the force of the impact. The banner and towline were found on the airfield boundary and the residential area.

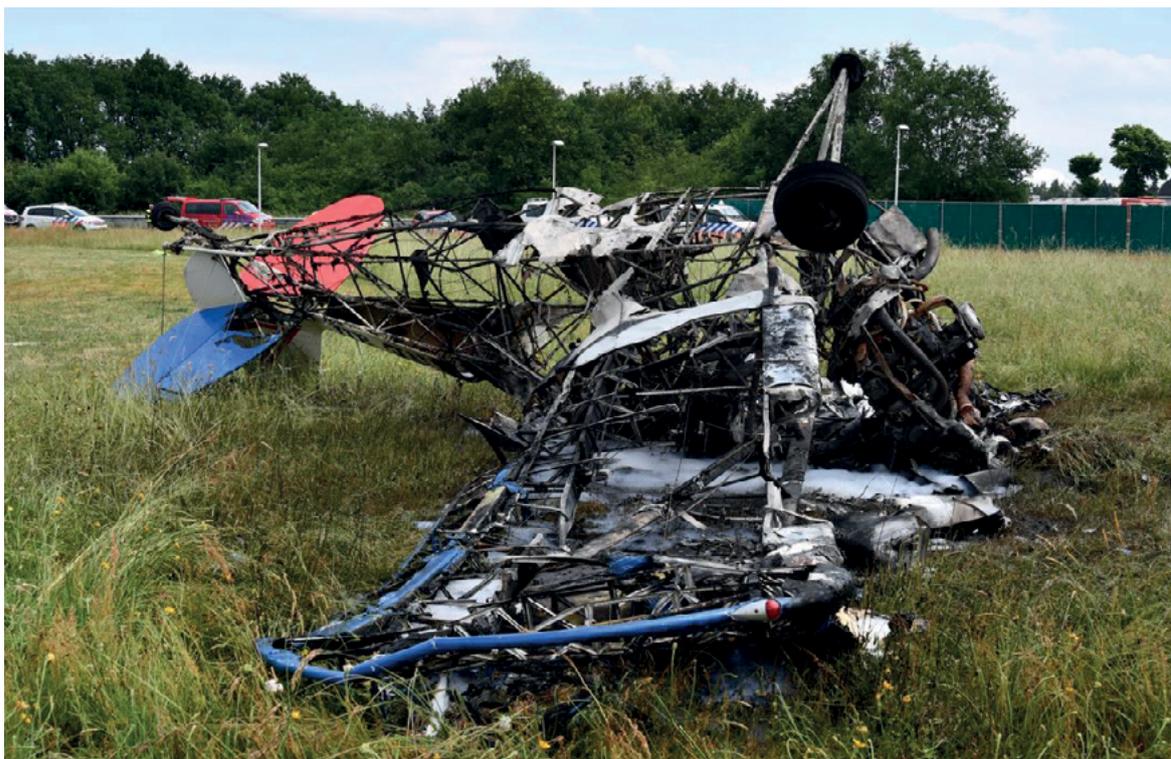
Figure 4: Wreckage of SE-KHF. (Source: Dutch Aviation Police)

The aeroplane was destroyed by the impact of the crash and subsequent fire. Although most of the aeroplane was severely damaged, a technical investigation was performed on the engine, cockpit controls, banner tow release system and the propeller. The following findings were made:

- a. The technical state of the engine did not reveal any malfunctions.
- b. The cockpit engine controls were found to be in the following positions: throttle – *full power*, mixture – *rich* and carburettor heating – *cold*.
- c. The aeroplane was equipped with a towing and tow-release installation. The banner release installation was tested and functioned normally.
- d. The wooden propeller blades of the 4-blade propeller were completely fragmented on impact with the ground, only the propeller hub/core was still attached. The fragmentation of the propeller blades showed that the engine was running at high rpm.

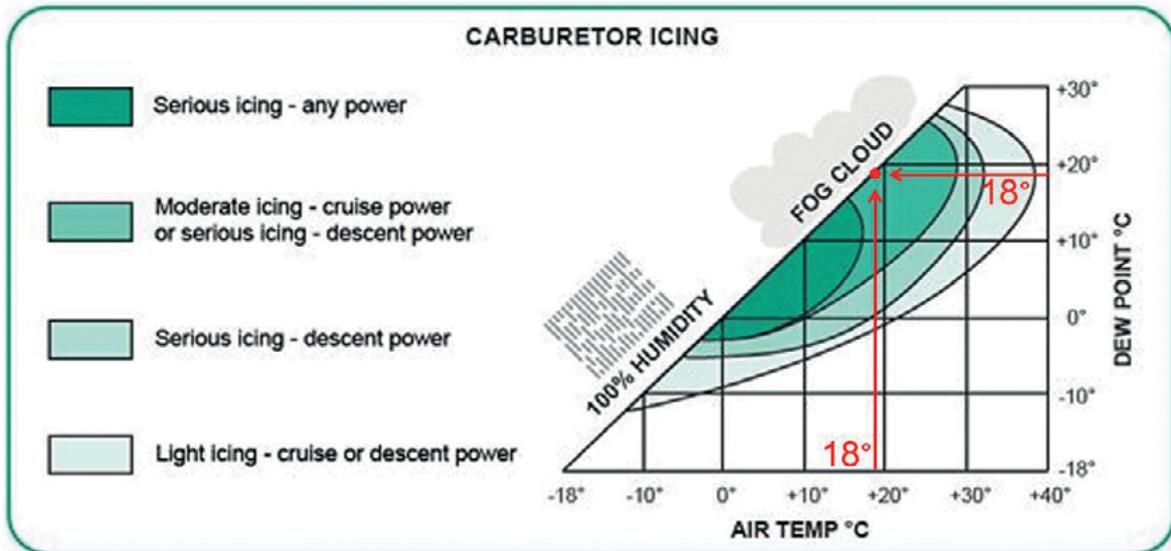
Figure 7: Carburettor icing prediction chart. (Source: Canadian Transportation Safety Board)

The actual carburettor icing conditions at the moment of take-off are notable and should be considered. The outside air temperature at the time of take-off was 18 °C and the dew point temperature was also 18 °C. With these temperatures the red dot in Figure 7 shows that the conditions were favourable for moderate to serious icing during cruise and descent with a low power setting. SE-KHF flew one circuit in the pattern of Breda Airport, before the pick-up of the banner. This is considered similar to a cruise/descent phase of flight. The carburettor heating controls in the cockpit were found in the 'Cold' position; which was the correct position during the pick-up and climb out with a high power setting. From downwind to just before the pick-up, the correct position is "hot", to prevent carburettor icing and guarantee maximum available engine power during the pick-up. It is unknown what the position was during the circuit.

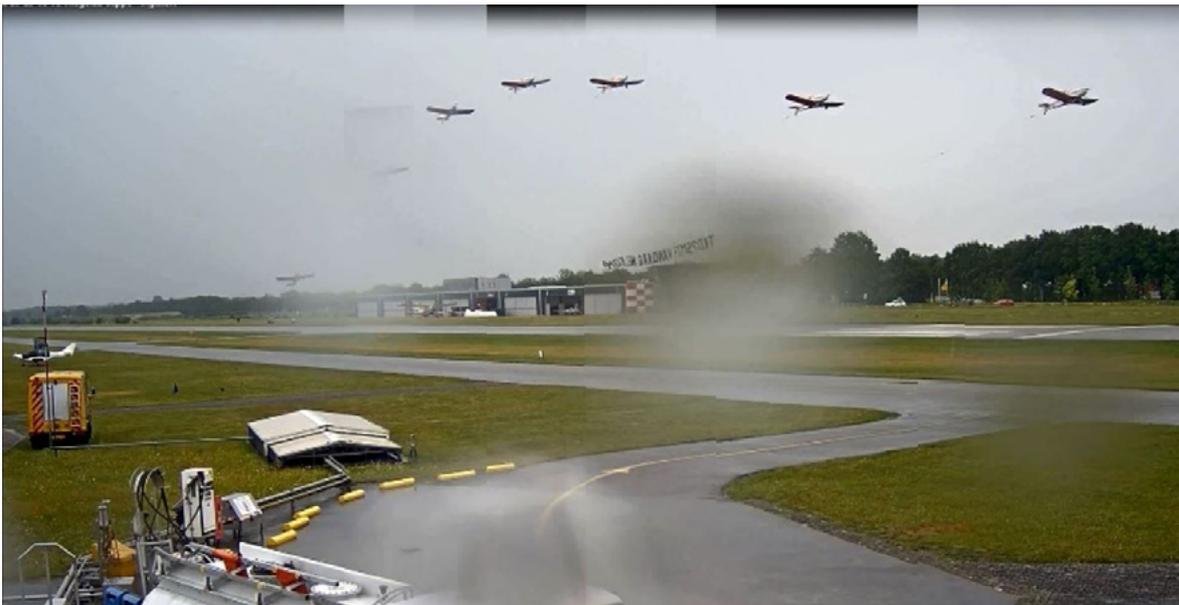
The flight path reconstruction in Figure 8 shows that after the pick-up of the banner, the aeroplane quickly developed a nose high attitude and a descending flight path. These indications are characteristic for a low airspeed situation. Therefore, an estimation of the aeroplane's hypothesized low airspeed was made by using the video images.

Figure 8: Video compilation showing the moment of the banner pick-up and the descending flight path.
(Source: Breda International Airport, modified by the Dutch Safety Board)

The aeroplane flew 620 metres from the position where it picked up the banner until the position where it fell over its right wing in 30 seconds. From this distance and time, a ground speed of 47 mph IAS (41 KIAS) (21 m/sec) was calculated. Taking into account that a head wind component of approximately 6 mph (5 knots) was present (the windssock is hanging almost vertically down), the aeroplane flew with an estimated average airspeed of 53 mph IAS (46 KIAS).

minimum indicated airspeed for the similar type aeroplane is 67 mph²⁰ IAS (58 KIAS). By comparing these airspeeds with the above calculated average airspeed, it is inferred that the airspeed had decreased to below the minimum recommended flying airspeed for normal and for banner towing operations, and that as a result the aeroplane had stalled.

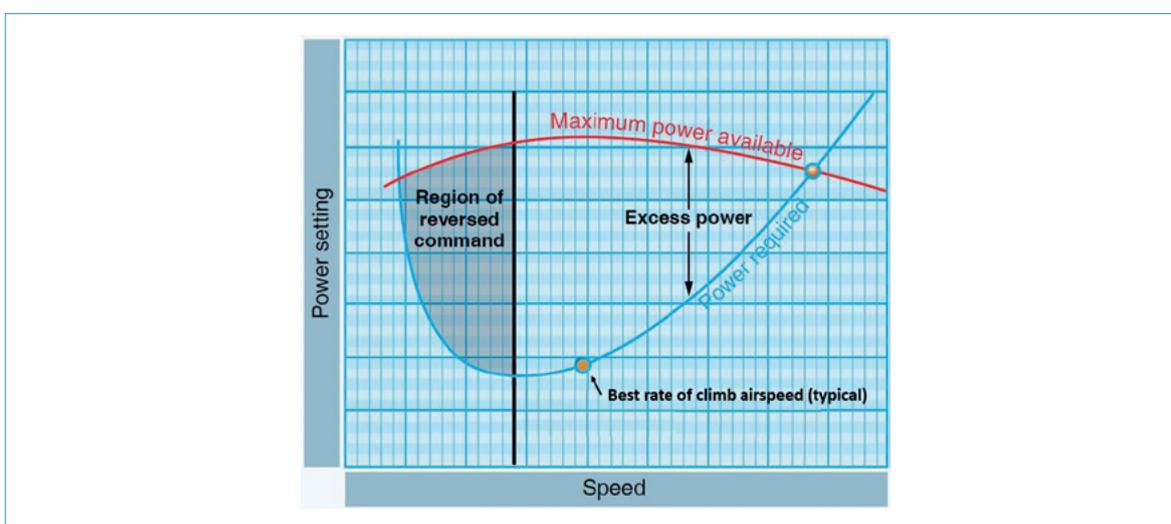
At the calculated average airspeed, the aeroplane was flying in the 'region of reversed command'. Figure 9 illustrates a typical region of reversed command, indicating that when flying at airspeeds below the best rate of climb airspeed, more engine power (thrust) is required to maintain a lower airspeed. This is indicated by the power required curve (blue line) going left and upwards. It also shows that the power required curve on the left side of the graph has a steep rise, indicating that when the thrust deficient situation is not corrected promptly, the decrease in airspeed worsens at an increased rate.

Figure 9: Typical region of reversed command. (Source: FAA, modified by the Dutch Safety Board)

At a certain point after the pick-up, the airspeed had decreased to where the aeroplane was flying in the region of reversed command. This means that flying a lower airspeed required more thrust to maintain that lower airspeed or to accelerate. Hence, the situation worsened as the speed of SE-KHF was decreasing gradually after picking up the banner. This situation could only be resolved by applying sufficient engine power (thrust) and/or by exchanging altitude (nose down) to increase the airspeed. The pilot could do neither of these, having an improper propeller fitted and being too low to the ground.

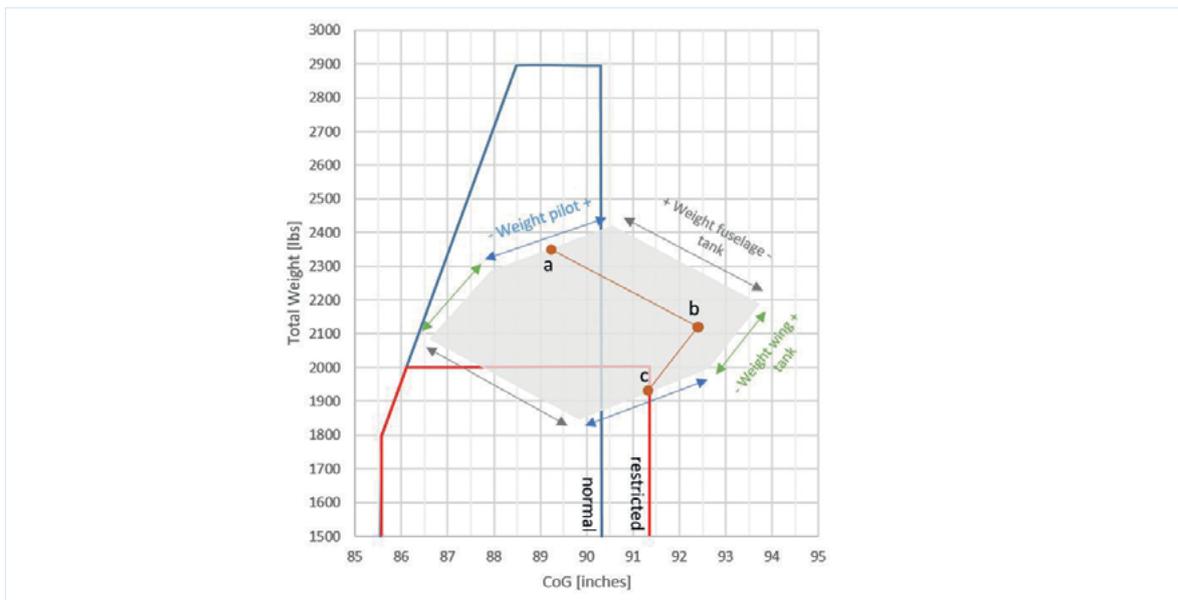
The graph in Figure 10 illustrates the aircraft flight manual weight and balance regions for the normal (blue) and restricted (red) categories.³⁴ The graph further shows the actual weight and balance region of SE-KHF (grey area). The line 'abc' within the grey area, shows the centre of gravity change as a result of decreasing weight due to fuel consumption.

Figure 10: The centre of gravity limits for the normal and restricted categories (SE-KHF).
