Report: EP201410210164

Nederlandse Aardolie Maatschappij

Technical evaluation of Twente water injection wells ROW3, ROW4, ROW7, ROW9, TUB7 and TUB10 3 years after start of injection

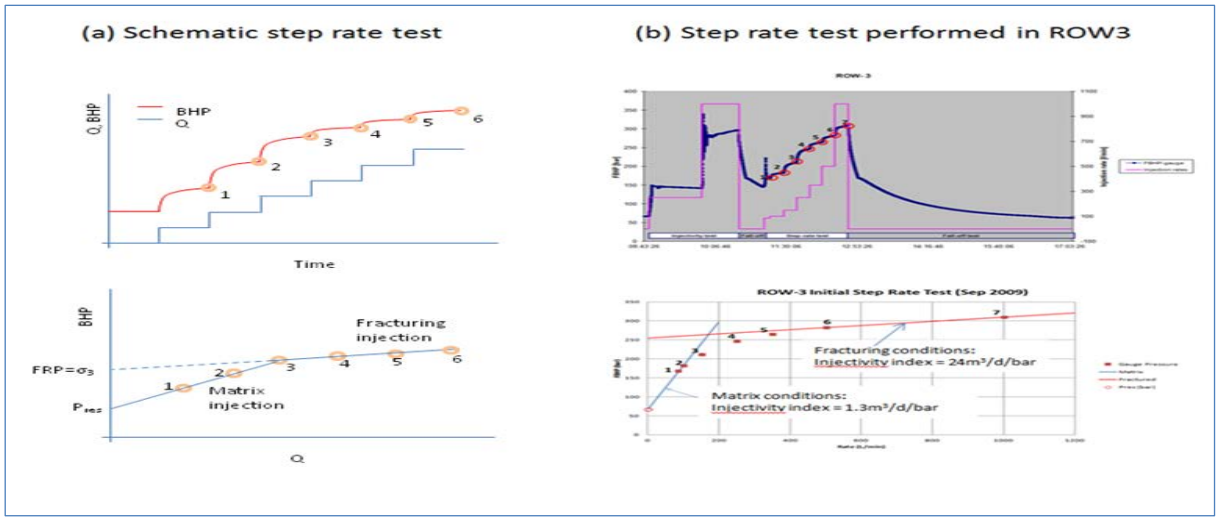
Figure 4 – Step-rate test principle applied in well ROW3

The SRT-data is presented for each well in Attachment 9.3. From the resulting plots, showing the BHP vs. Q, it is obvious from the slope change that formation breakdown occurred only in ROW3 (Attachment 9.3.1). Consequently, the injectivity (expressed in m^3/d/bar) increases. For the other wells, where water is injected into the fractured Zechstein Carbonate reservoir, the SRT-plots all show a linear trend. As expected, in most wells only a very low BHP is required to inject the planned water volumes. This is because the local reservoir pressure is very low and because injectivity is in general very good. Note that the curve intersects the y-axis at approximately the reservoir pressure.

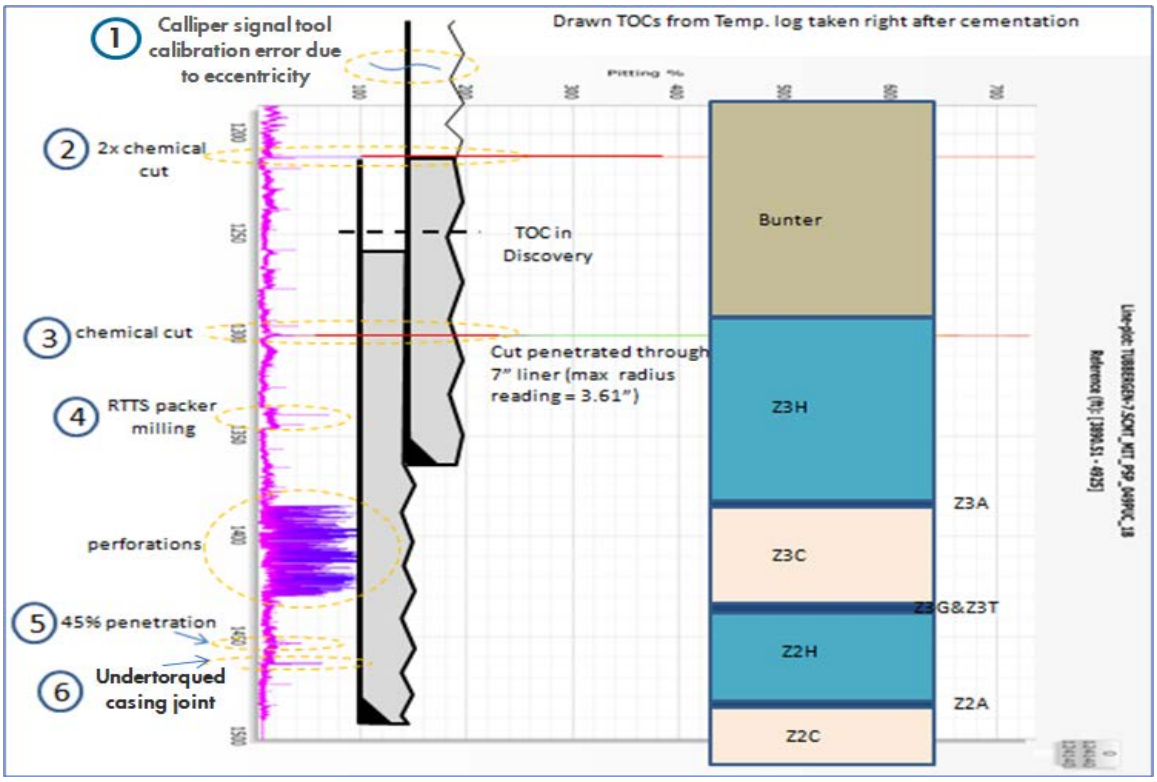
Whilst deemed unlikely that a potential exposing of the ZeZ2H to injection water has occurred, the existence of multiple integrity risks in one well has led NAM to shut the injector in. Because of the high TUB7 injection capacity of 2000 m^3/d and the remaining storage volume of 4.2 million m^3, the plan is to restore this well as injector. An investigation into the best possible repair options is ongoing. A detailed discussion of the extensive surveillance performed in TUB 7 can be found in Attachment 9.7.

Figure 6 – PMIT-A calliper readings in TUB7

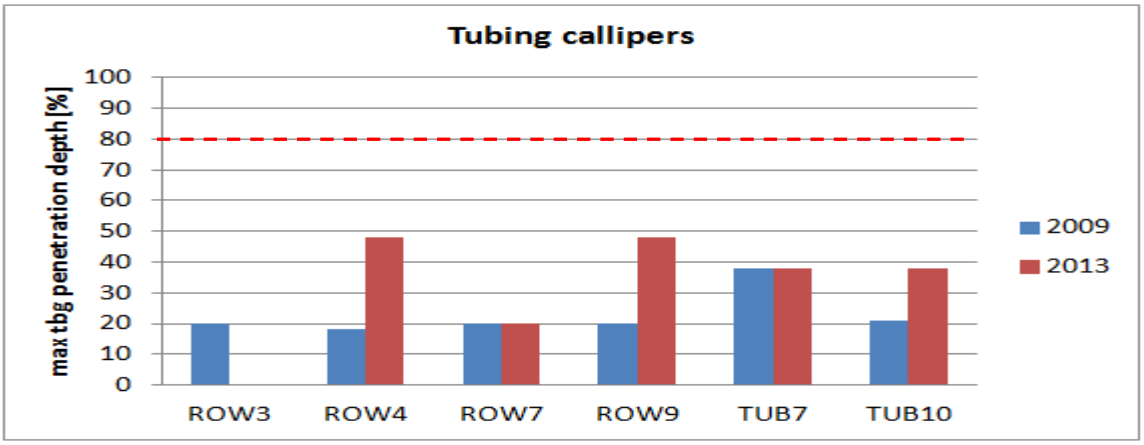
Figure 9 below shows results of callipers taken in the tubing of the water injection wells in 2009, i.e. before start of water injection, and in 2013 3 years after start injection. It shows the maximum pit penetration (as measured in one or two tubing joints) as percentage of the original wall thickness. The results show that the tubing condition has significantly worsened in wells ROW4 and ROW9, whereas it more or less stayed the same in wells ROW7, TUB7 and TUB10. No tubing calliper was carried-out in ROW3 as this well is shut-in until injection is resumed once the pump envelope is appropriate. When water injection will be resumed a new tubing calliper run will be performed.

Figure 9 - Tubing calliper results (max observed pit penetration as % of original wall thickness). The dashed red line indicates the approximate maximum acceptable penetration limit.

The remaining wall thickness and the required wall thickness to withstand the maximum expected pressure difference across the injection tubing are given in Table 8. The calculations show that all tubings still have enough wall thickness even at maximum injection pressure. Still, to secure sufficient injection capacity in the future, workover might be required in ROW4 and ROW9 to either replace the tubing or to protect the current tubing by installing an insert injection string.

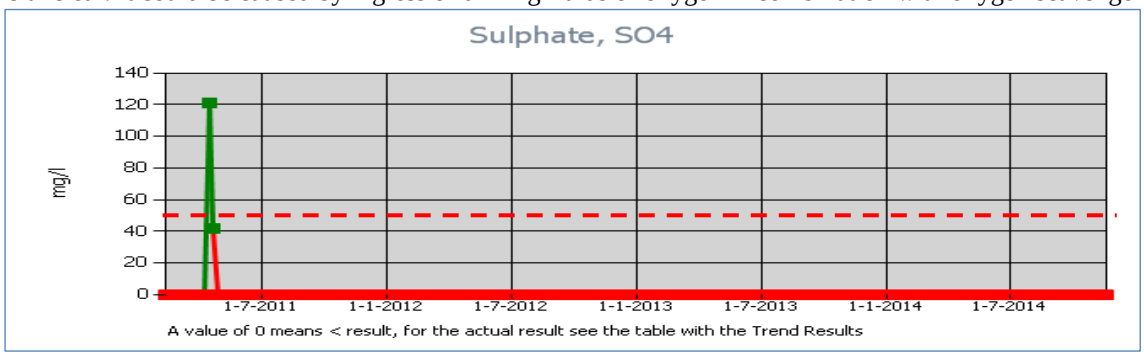
- Sulphate
  In Figure 10 it can be seen that the sulphate levels are always below the detection limits (~25 mg/l) except twice in 2011. The expected maximum value (50 mg/l) is exceeded only once. The reason for this excursion is unclear. It could be caused by ingress of drilling fluids or oxygen in combination with oxygen scavenger.

Figure 10 – Sulphate concentration from 2011 until 2014. The dashed red line indicates the expected max. value.

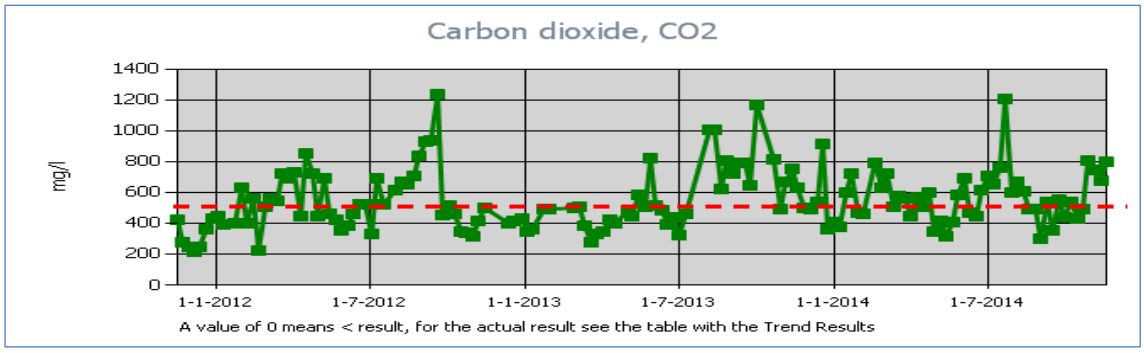
- Carbon dioxide
  From Figure 11 it can be seen that the CO_2 content in injection water is often above the expected maximum of 500 mg/l. CO_2 originates from the reservoir where the content is even higher than in the disposal water. The CO_2 partitioning between water and gas in the production system depends on the CO_2 concentration in the associated gas, temperature, pressure, pH, and residence time in the production system and is difficult to predict. It must be concluded that the expected maximum was set too low. CO_2 is not included in the EURAL list as it is not harmful in the measured concentrations (reference, sparkling mineral water contains ~5 g/l).

Figure 11 – Carbon dioxide conc. from 2011 until 2014. The dashed red line indicates the expected max. value.

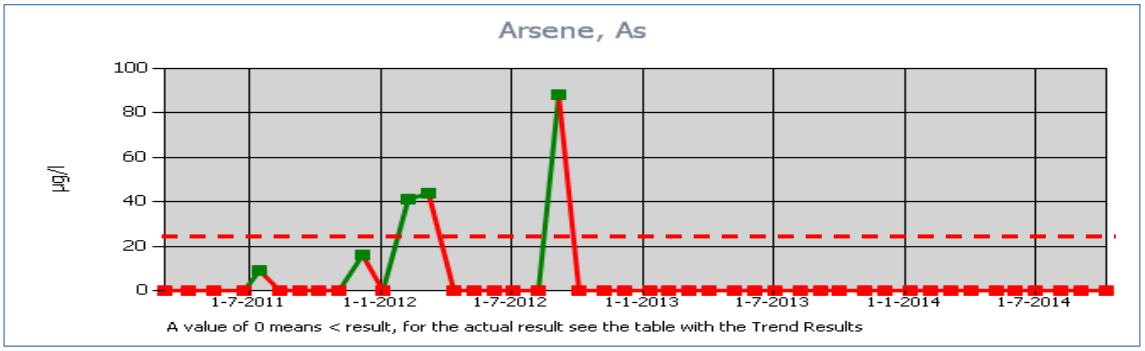
Figure 12 - Arsenic concentration from 2011 until 2014. The dashed red line indicates the expected max. value.

- Arsenic
  Arsenic is a toxic component of the formation water and is normally present in very low concentrations, below its detection limit of 10 µg/l. The maximum expected value is 25 µg/l. On 3 occasions a higher concentration was measured (Figure 12). Arsenic may be released when steam comes in contact with isolated minerals in the reservoir that contain Arsenic (such as certain clay minerals). This may explain the sporadic concentrations above the expected maximum. When setting the expected maximum level, such natural mineral bound excursions were not taken into consideration.

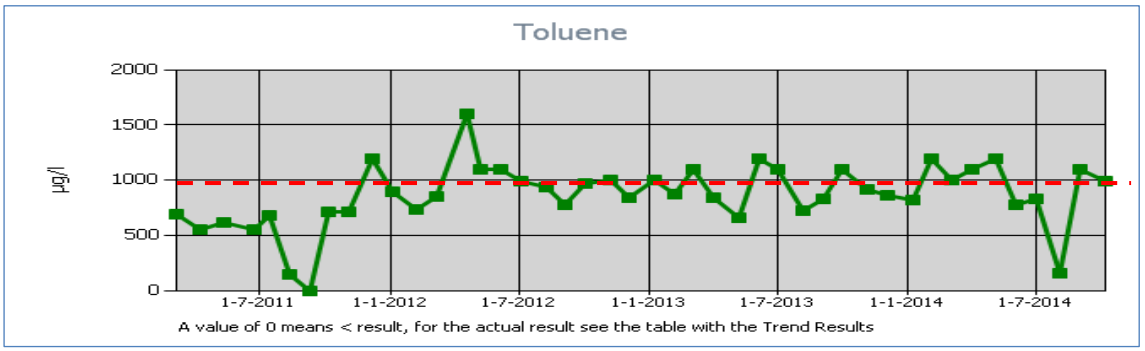
Figure 13 - Toluene concentration from 2011 until 2014. The dashed red line indicates the expected max. value.

From Figure 13 it is evident that the toluene content in the injection water hovers around the previously expected maximum of 1000 µg/l. Toluene originates from the oil (which contains ~0.1% of toluene) although small amounts can also be present in some processing chemicals as part of the solvents. Toluene partitioning between water, gas and oil in the production system depends on the toluene concentrations, temperature, pressure and residence time in the production system and is, therefore, difficult to predict. The expected maximum concentration was predicted too low.

Toluene is hazardous. However, the observed concentrations are still many orders of magnitude below the EURAL limit (250 million µg/l). Toluene belongs to the group of aromatic compounds. When considering aromatic compounds as a group it is more important to consider Benzene, a highly carcinogenic chemical. The maximum observed Benzene concentration (4400 µg/l) is within the maximum expected concentration (5000 µg/l) and orders of magnitude below the EURAL limit (1 million µg/l).

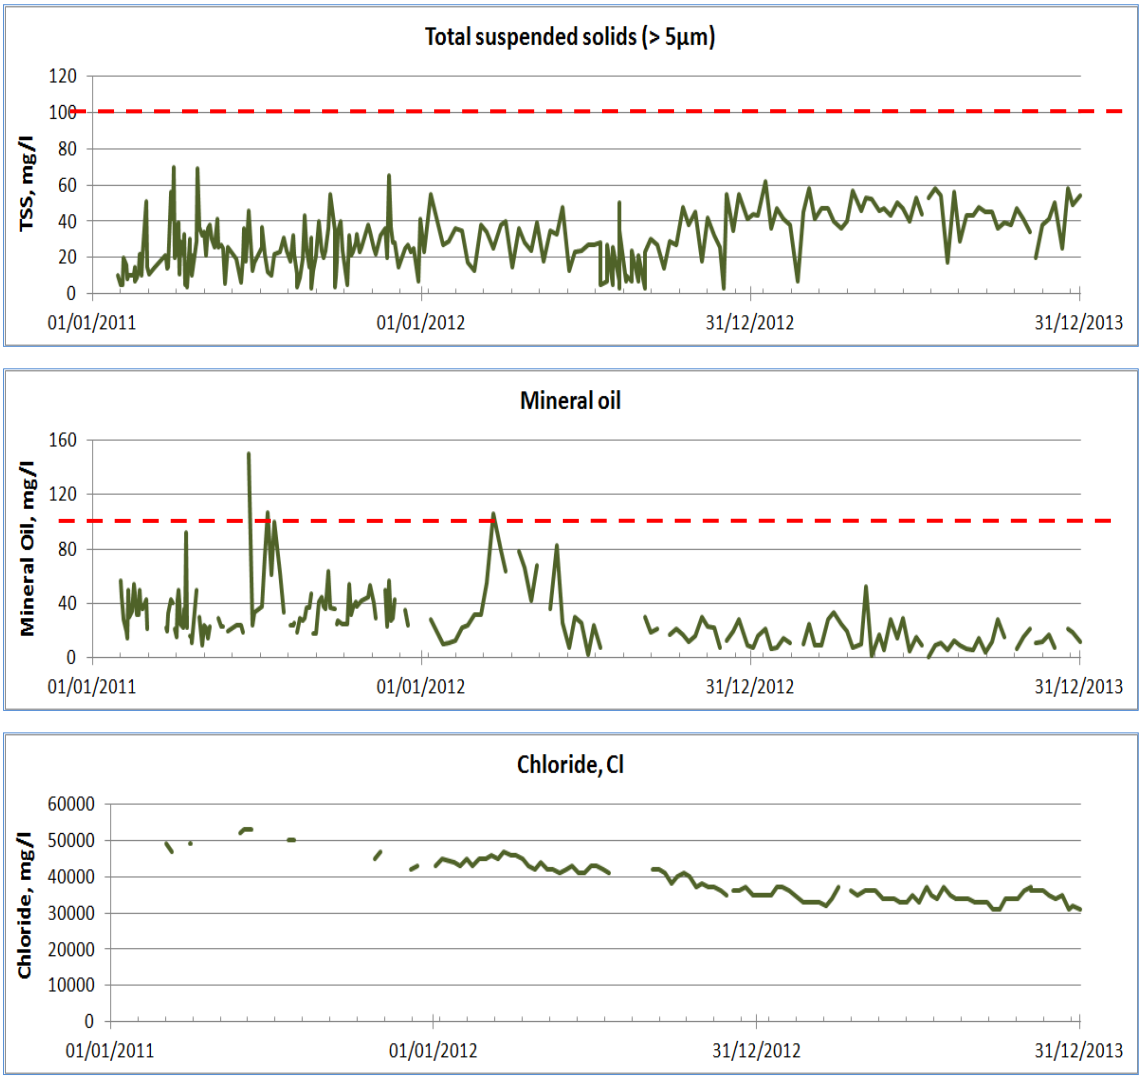
Figure 14 – Suspended solids, oil-in-water and chloride concentrations measured in the injection water at the CTF. The dashed red line indicates the expected max. value. Note that there is no limit for the chloride concentration.

Of all monitored parameters, the Chloride level, the oil-in-water concentration and the total suspended solids larger than 5 micron are considered key for ensuring proper management of the water injection activities. Solids content and oil-in water are important parameters as these can cause plugging of the perforations and fracture networks in water injection wells and reservoirs. To avoid excessive plugging, limits have been set, i.e. 100 mg/l for both parameters. Figure 14 shows that so far (period jan11-jan14) the solids and oil content have stayed within these set limits.

Table 10 also shows that the oil-in-water concentration, measured in samples at the CTF, exceeds the values measured at the Twente injection wells. The oil-in-water concentration, measured during 2013 at the CTF, varied quite a lot with in the range of 0.7-52mg/l (Figure 14). The oil-in-water concentrations in Twente in this same period fall within this bandwidth. A possible cause for the variation could be contaminations observed in the wells: Common practice for all wells is that wireline interventions are preceded by bullheading 30 m^3 of hot water to clean the tubing, flushing the oil and solids towards the reservoir. On some occasions, however, retrieved wireline tools were covered with a black pasta of solids and oil/wax containing elevated levels of Fe, FeO, S, Ca, Si and $CaCO_3$. This suggests that some wells were so dirty that the clean-out was not sufficiently effective and that some of these contaminants could have been back produced. Overall however, the data indicate that that the oil-in-water quality is within allowed limits.

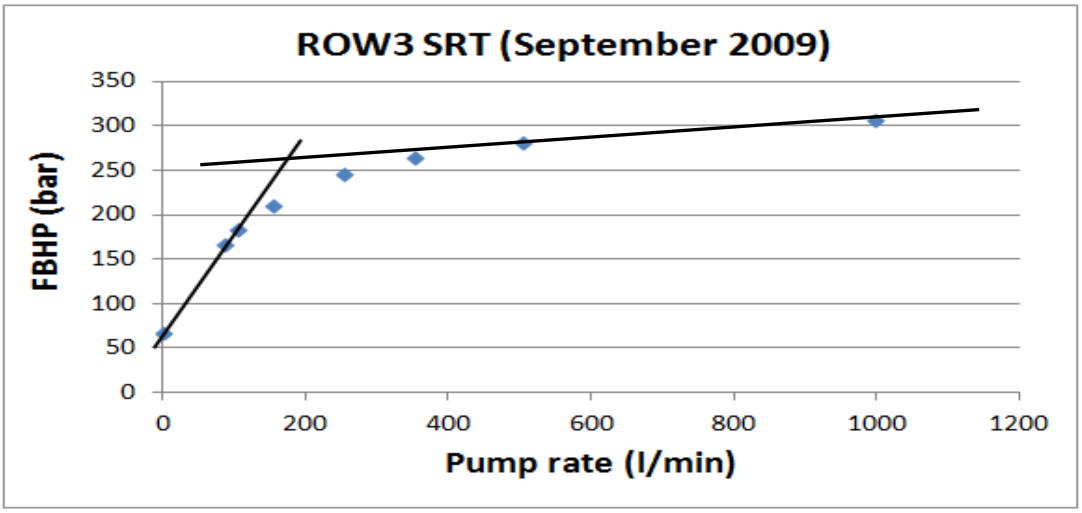
9.3.1 Well ROW3

The low injectivity in ROW3 is due to the fact that the Carboniferous sandstone reservoir for this well does not contain a natural fracture network. In order to determine a safe operating envelope, the formation breakdown conditions were determined during a formation integrity and injectivity test in 2009. The test (ref SRT-plot in Attachment 9.3.1) shows that formation breakdown occurred at a low pump rate of 150-200 l/min and that but even under frac conditions the injectivity did not increase much. For comparison, in conventional hydraulic fracturing of gas wells, the injection rate applied for formation breakdown and fracture propagation is typically 10-15 times higher (2500-3500 l/min). It is expected that during the injectivity test small fractures were created in the formation but that these did not propagate away from the ROW3 well bore.

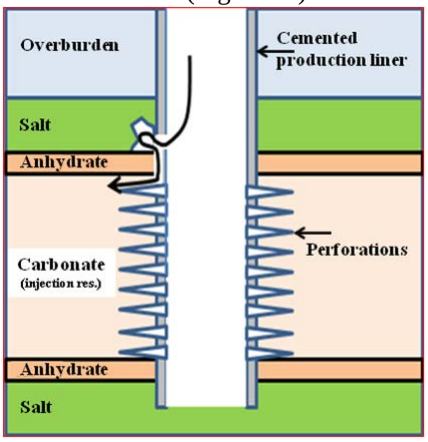
Figure 15 – Near-wellbore salt dissolution scenario in case hole in casing lining-up with the Halite formation

Near the injection well a hydraulic connection can exist between the Carbonate reservoir and the overlying Halite seal via cracks in the production casing cement. In case these cement cracks line up with any potential holes in the casing, e.g. caused by potential corrosion, then this could allow flow past the Halite allowing halite dissolution (Figure 15).

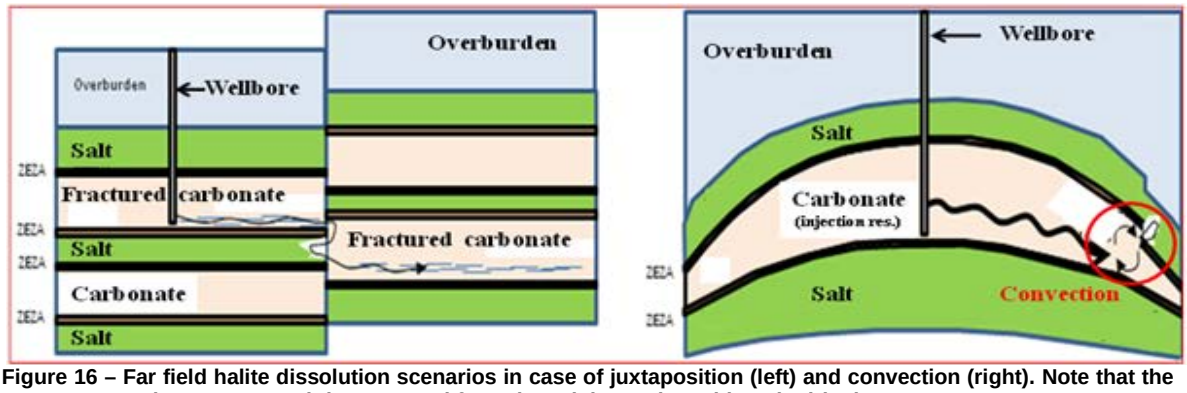
Figure 16 – Far field halite dissolution scenarios in case of juxtaposition (left) and convection (right). Note that the carbonate reservoir is separated from the salt layers by a thin anhydrite layer.

In unfaulted areas, contact between the injection water and Halite formations is highly unlikely in view of the presence of continuous anhydrite layers, which shield off the Carbonate injection reservoir from the over- and underlying Halite formations. In faulted areas Halite rock can be juxtaposed against the Carbonate injection reservoir provided the fault offset exceeds the thickness of the over/underlying anhydrite formation (Figure 16).

In a faulted area a "Halite flow past scenario" could occur when (i) injection water flows laterally from the injection well to juxtaposed Halite rock where it can dissolve the Halite and (ii) in a faulted area at the down-dip flanks of the injection reservoir. In the first case, to sustain any dissolution, the water needs to flow vertically away from the Halite/Carbonate interface in order to allow a continuous supply of relatively fresh (low saline) water towards the exposed Halite rock. In the second case, when low saline water collects in the down-dip flanks over time, a convection loop could occur where injection water dissolves overlying Halite rock. Due to gravitational forces, salty water settles allowing relatively lighter injection water to rise from the bottom of the injection reservoir to the exposed overlying Halite rock.

The Halite dissolution modelling results showed that in the far-field, fluid velocities are too small to cause significant Halite dissolution. This is because the vertical communication within the injection reservoir is very low (k_v/k_h ratio is in the order of 10^{-3} to 10^{-4}, EP201310201845). Any low saline water reaching Halite rock, exposed to the injection reservoir due to faulting, therefore cannot flow away fast enough from the Halite to cause any significant dissolution rate.

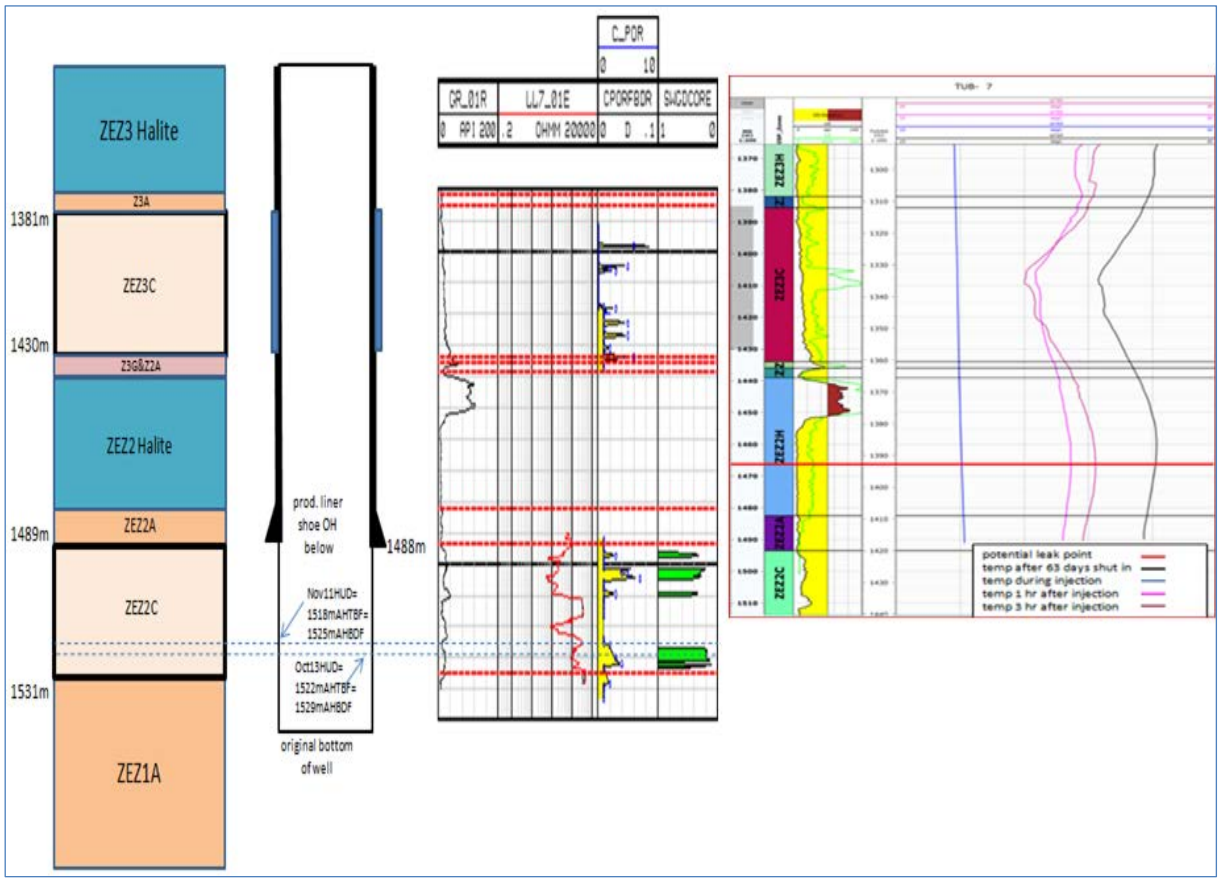
9.5.5 Well TUB7

the Z2H, which is located in between the Z2C and Z3C injection reservoirs. Temperature logs can always show some "smearing" effect. Because of the injection of significant volumes of cold water preceding the temperature survey it is very likely that the ZeZ2H in between the 2 injection reservoirs as well as the ZeZ3H directly overlying the ZeZ3C reservoir have cooled down as well, which causes the warm back during the shut-in period to occur much slower. Zooming in on these temperature surveys, shown for TUB10, however, does show that the warm back of the Z2H has started. For future temperature surveys it is recommended to prolong the shut-in period prior to a temperature survey to allow the Z2H to sufficiently warm back.

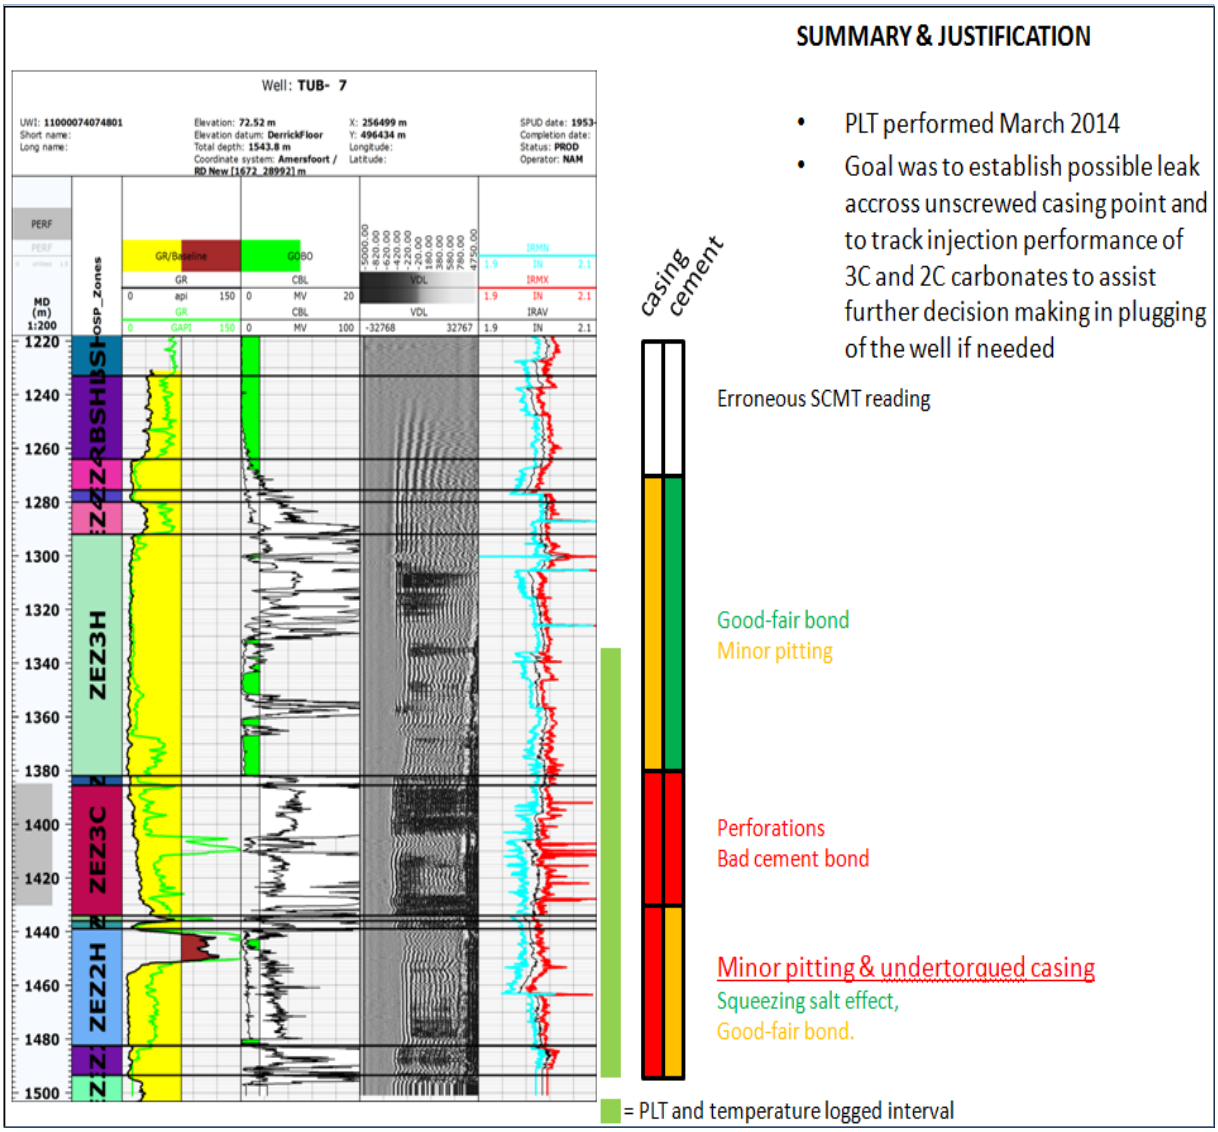
9.6.3 Well TUB7

The casing calliper results in TUB7 show that the casing integrity might be compromised at several depths. Although there is no evidence that actual leakage may have occurred, the risk of exposing Halite at the ZeZe2H and ZeZ3H to injection water is perceived such that the well has been closed in until a full investigation into repair options is concluded.

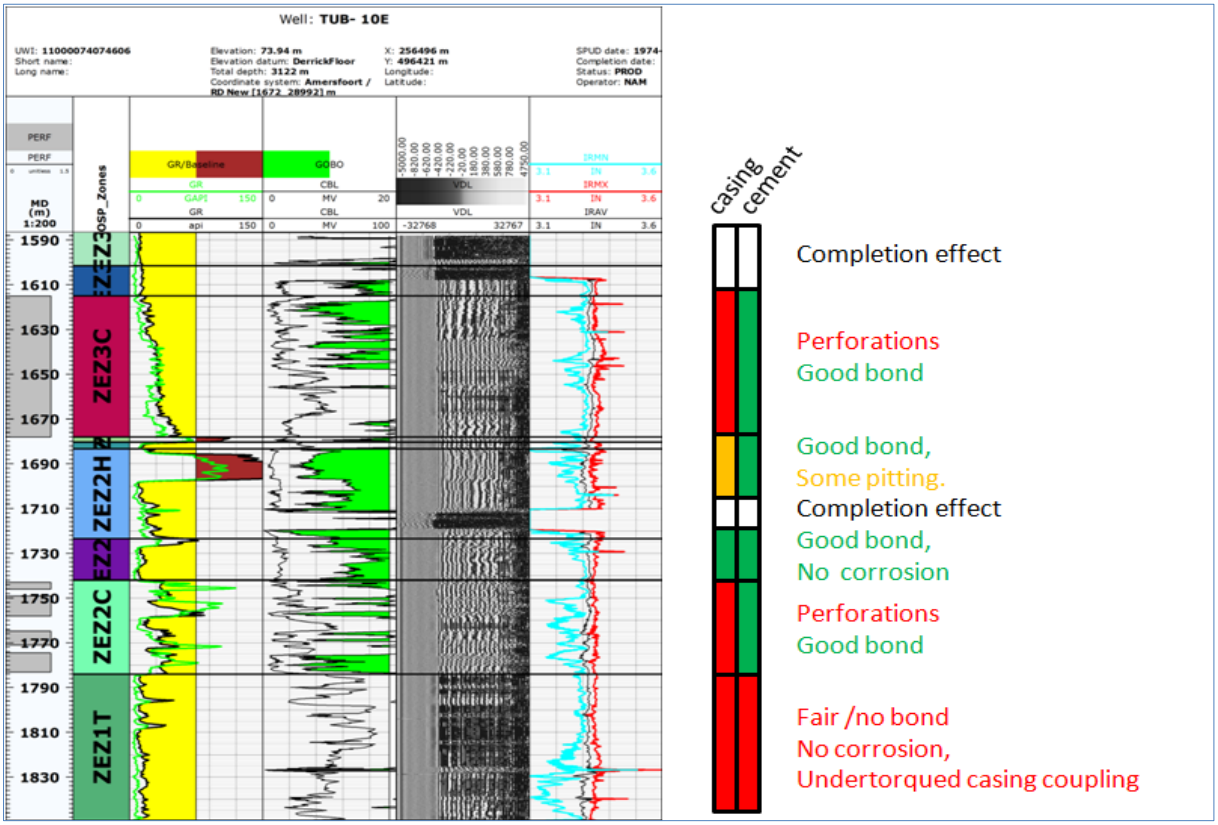
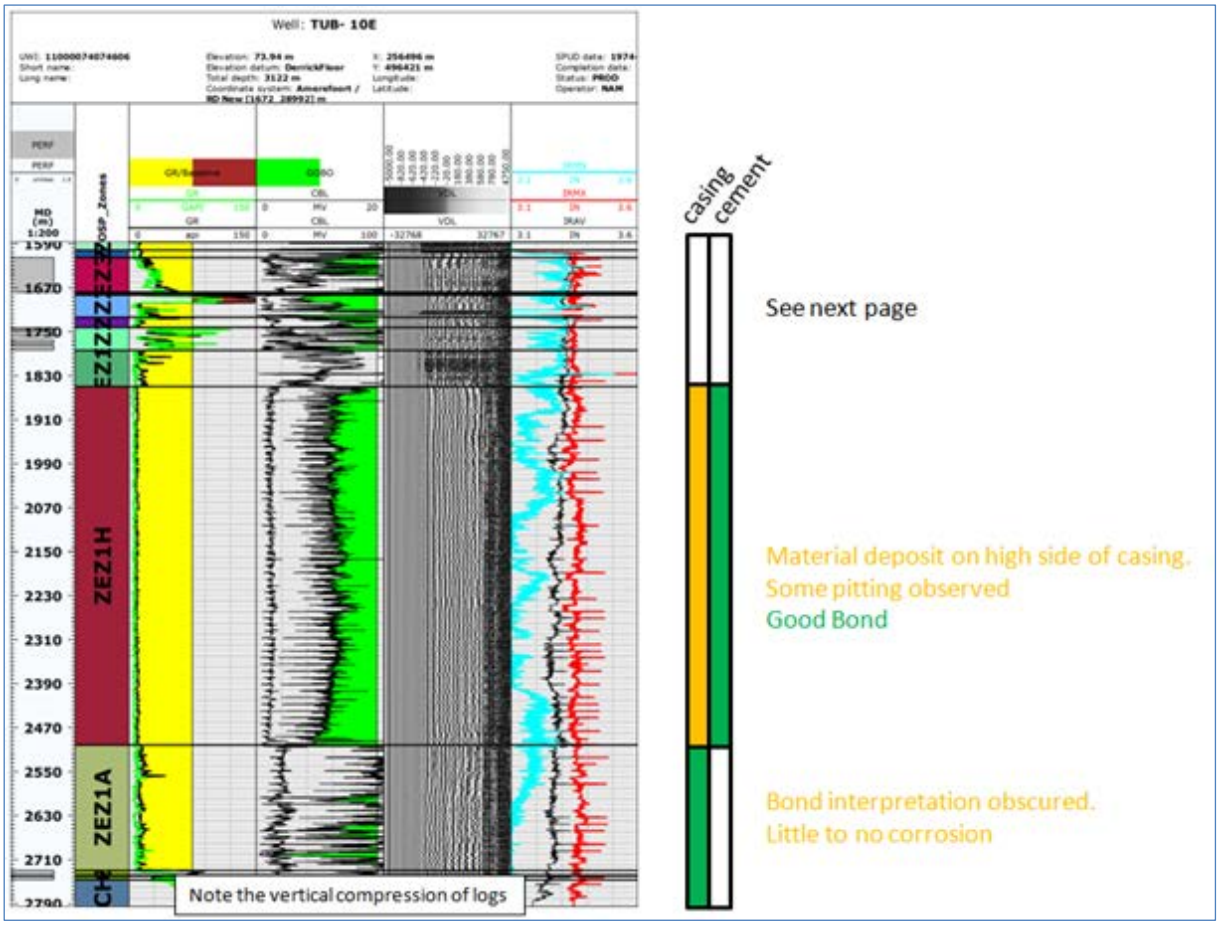
9.6.4 Well TUB10

In TUB10 (Attachment 9.6.4) the condition of the production liner underneath the packer was found to be good (maximum pit penetration into the casing is 33% of the original wall thickness). Also the cement bonds across the Carbonate and Halite sections were found to be good. The exception is at 1827 mAHbdf in the ZeZ1T Anhydrite, where a potentially undertorqued casing joint (Figure 7) was observer in combination with a poor cement bond. Considering that the potentially undertorqued casing joint is close to the underlying ZeZ1H formation, a potential risk exists that, in case the joint would leak, injected water might flow behind the liner and expose the ZeZ1H salt. This risk is considered to be small because the cement bond across the ZeZ1H is good (Attachment 9.6.4) preventing flow past the salt. Because of the good cement bond across the layers above the leak, the risk that the injected water might reach the ZeZ2H, also above the suspected joint, is considered unlikely.

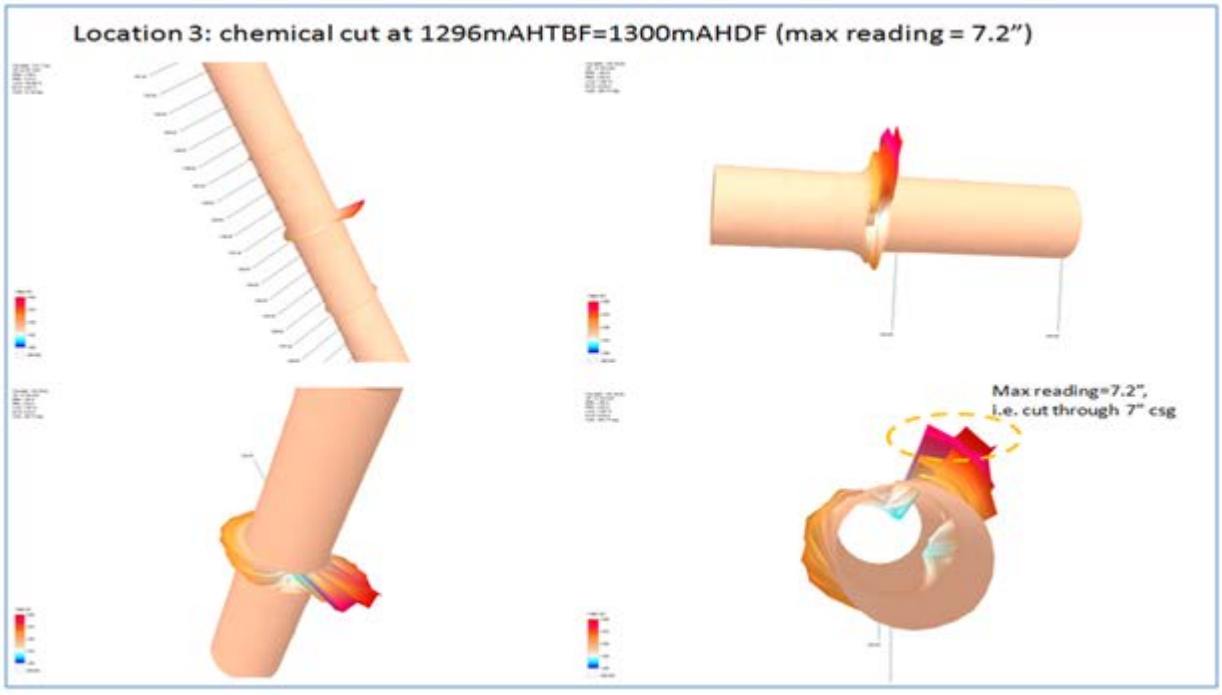
[3] At 1295 mAHtbf, the impact is visible of an unsuccessful chemical cut which preceded the cut discussed above. The PMIT-A calliper shows that the chemical cut did cut through the 4½" liner and the 7" casing (Figure 17). The cement bond behind the 7" casing was not verified as only a temperature log was run right after cementation. This temperature log does indicate a top of cement of 1210 mAHdf, but does not give any quality indication of the cement itself. However, fair-to good cement bonding is indicated across the ZeZ3H (Attachment 9.6.3), thus excluding a flow-past Halite scenario. It must be noted that the top of cement in the Attachment is measured at 1270 mAHbdf, because the CBL-tool only functions properly when immersed in fluid, which most likely coincides with that depth.

Figure 17 – PMIT-A calliper indicating cut through 4½"-liner and 7"-casing

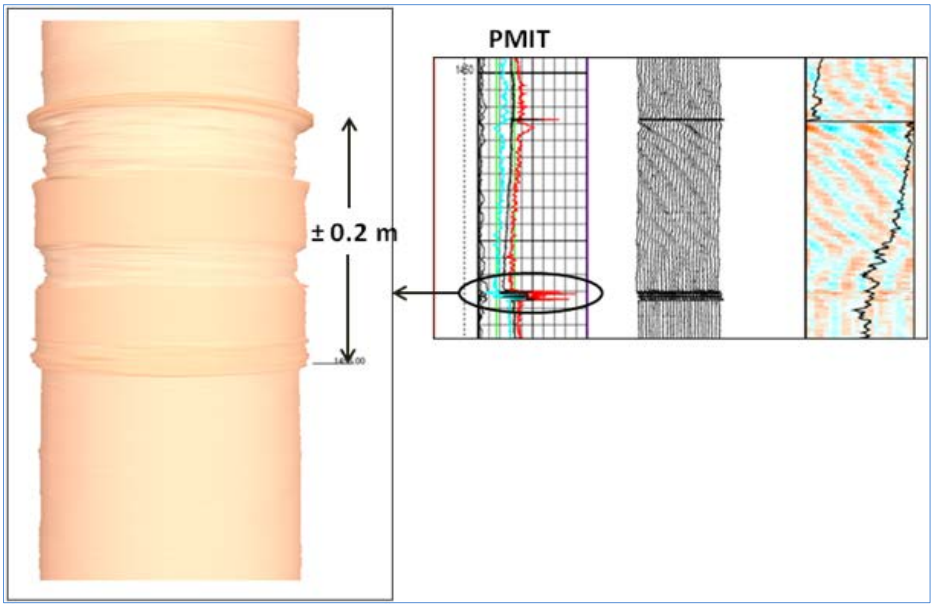
[6] The deepest potential integrity concern is at 1460 mAHtbf (1464 mAHdf), which is at the level of the ZeZ2H. The calliper and CBL signal observed are interpreted to represent a potentially undertorqued casing joint in a section with a poor cement bond. This carries the potential risk of directly exposing the ZeZ2H salt to injection water. Figure 18 shows the 3D-calliper image as derived from the PMIT-data.

Figure 18 – 3D-calliper image of the undertorqued casing joint at 1464 mAHdf

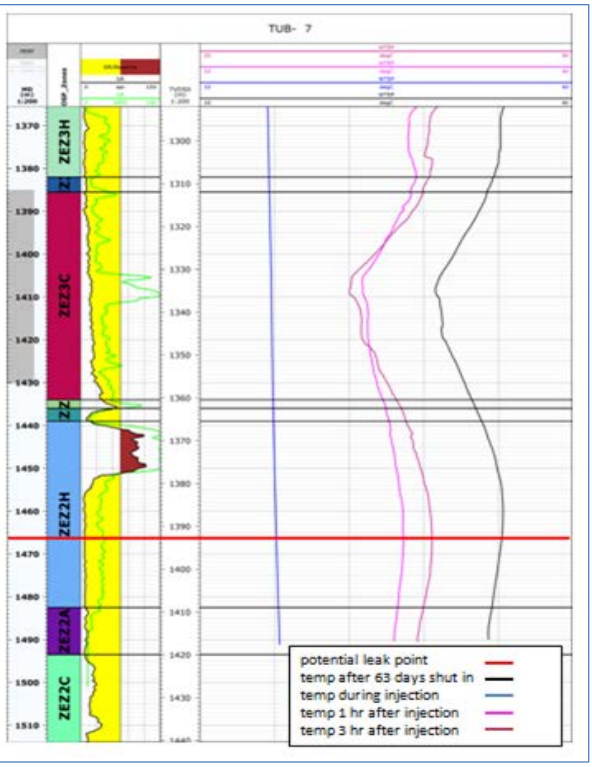
- A cooling effect from regular injection seazed 63 days before logging is still visible over 3C perforations
- During injection, remperature gauge only sees cold water (blue line)
- 1 hr after injection well warming is noticed from geothermal heat influx.
- 3 hr after injection this effect becomes more apparent, differences at different parts of the well bore as well. The overal temperature log seems to approach 'normal' shutin conditions again.
- No sign of any water injection at potential leak point becomes apparent.

Figure 19 – Temperature logging results

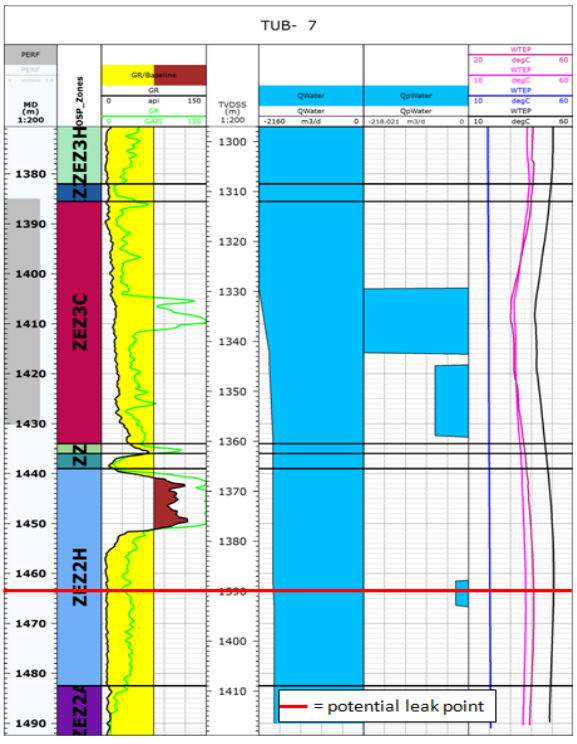
Summarizing: at higher injection rates it is increasingly difficult to rule out injection at leak point.

Figure 20 – PLT results
