# FIELD ASSESSMENT JAVA SEA

SURVEY OF THREE DUTCH WWII NAVAL WRECK SITES IN THE JAVA SEA

Progress Report

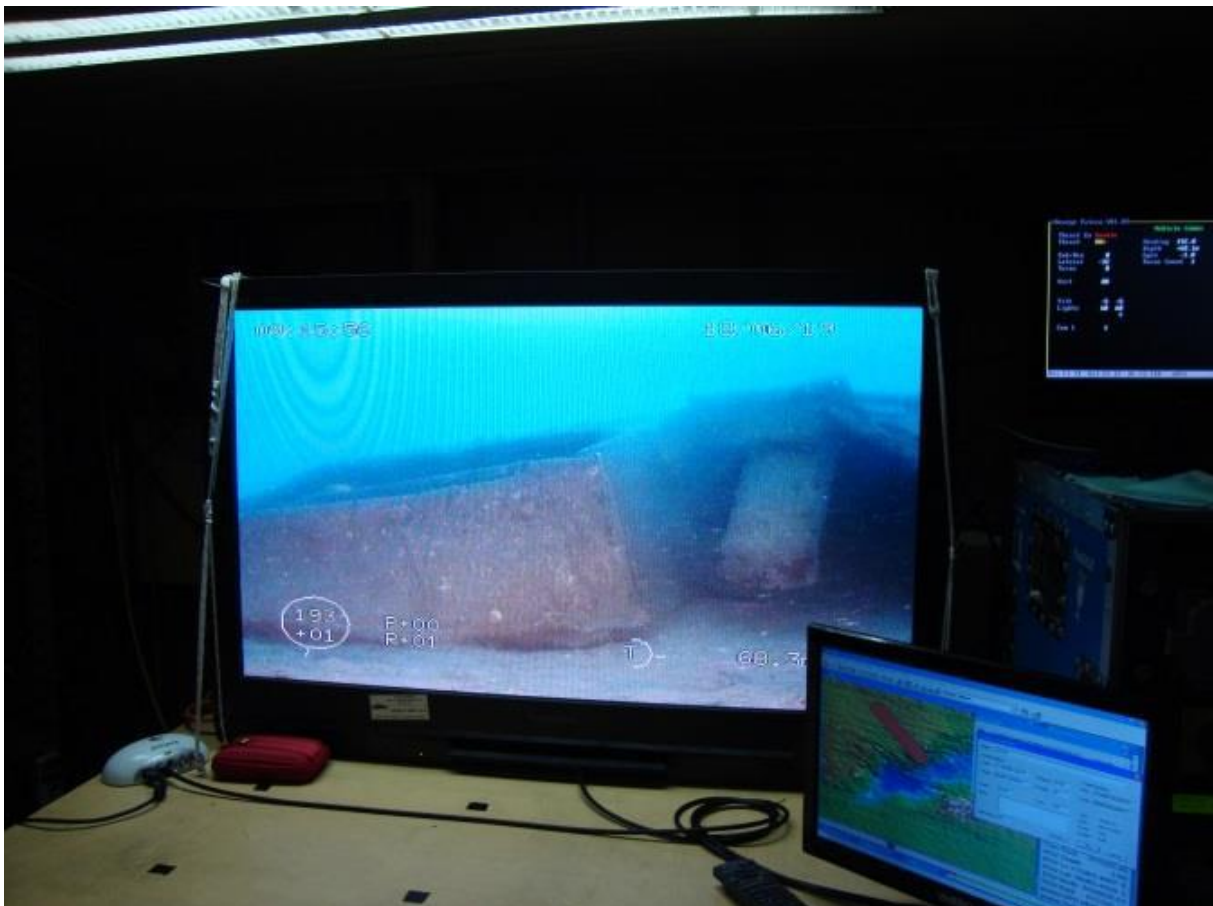
At the location of the *Kortenaer*, the already known ship section is particularly recognizable. This ship section is also visible on video made by the dive team in 2016. The height of this ship section is up to 10 meters in some places. Quite substantially, but the metal is very badly damaged and visibly pinched during the illegal salvage. Not much other parts were found around the ship section. The large part makes up somewhere between 10 and 15% of the total wreck, which was also the estimation of the dive team in 2016. The data has to be analysed further to make a more detailed estimate. No personal items were spotted while mapping the site with the ROV.

Figure 2: A photo made of the monitor during an ROV run.
